The Behavior of 3.11 Tsunamis in the Sendai Plain and the Damage of the Disaster Prevention System

**Akira Mano
Disaster Control Research Center
Tohoku University**

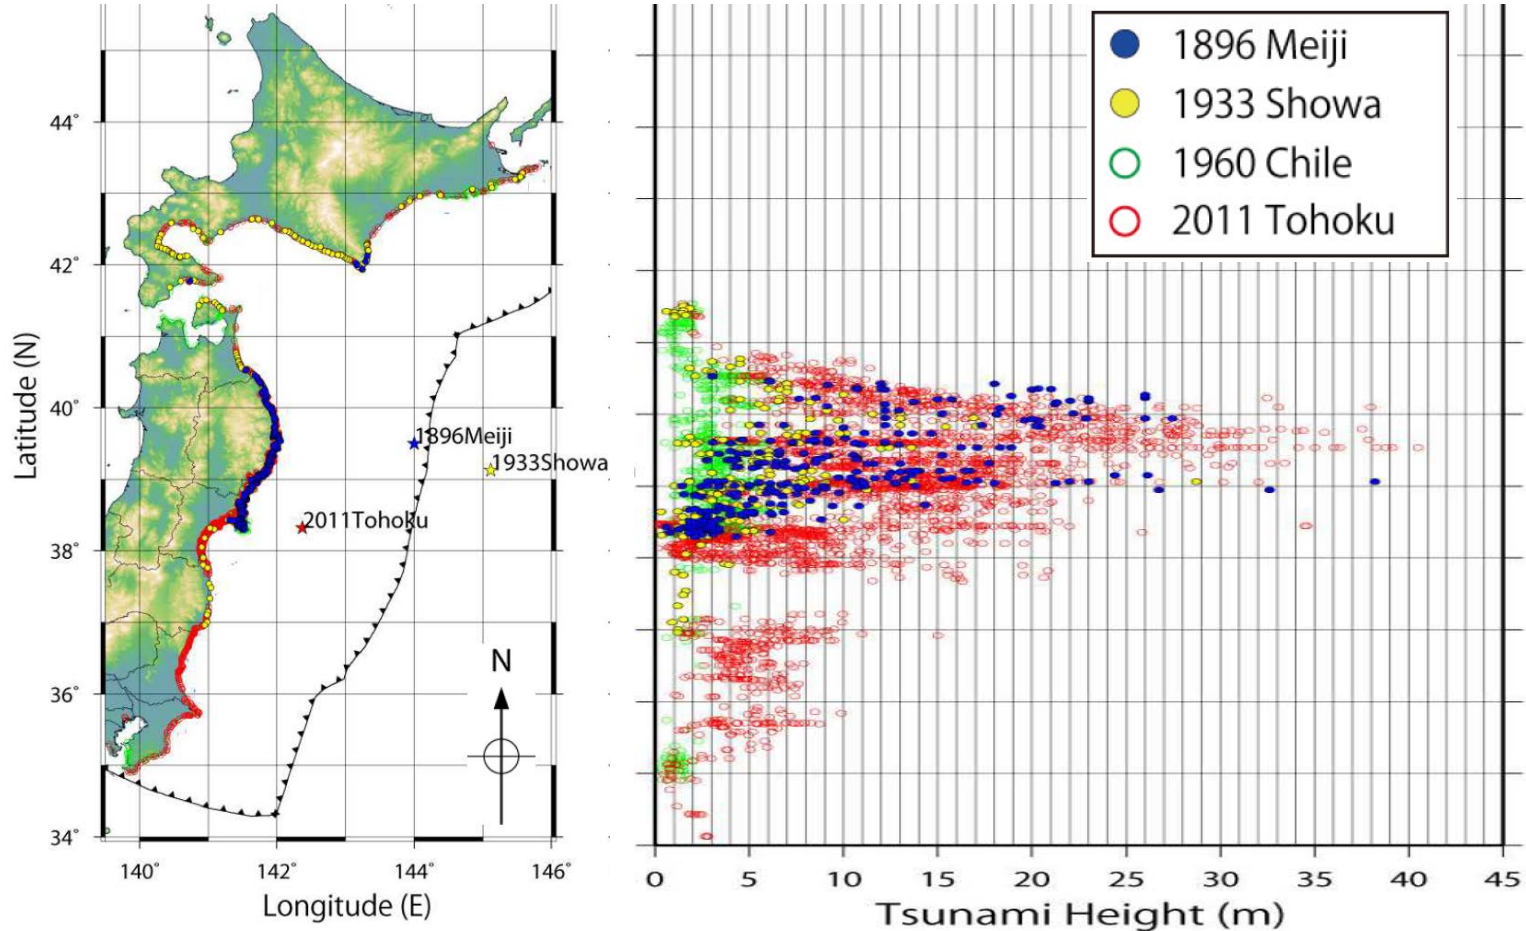
Tsunami height in 4 major events after Shigihara (2011)

Recent study finds Jogan Tsunami in 869 is similar to the 2011 tsunamis in the Sendai Plain through the sedimentological analysis, Sugawara (2011). This estimates RP of the tsunamis as a1000y.

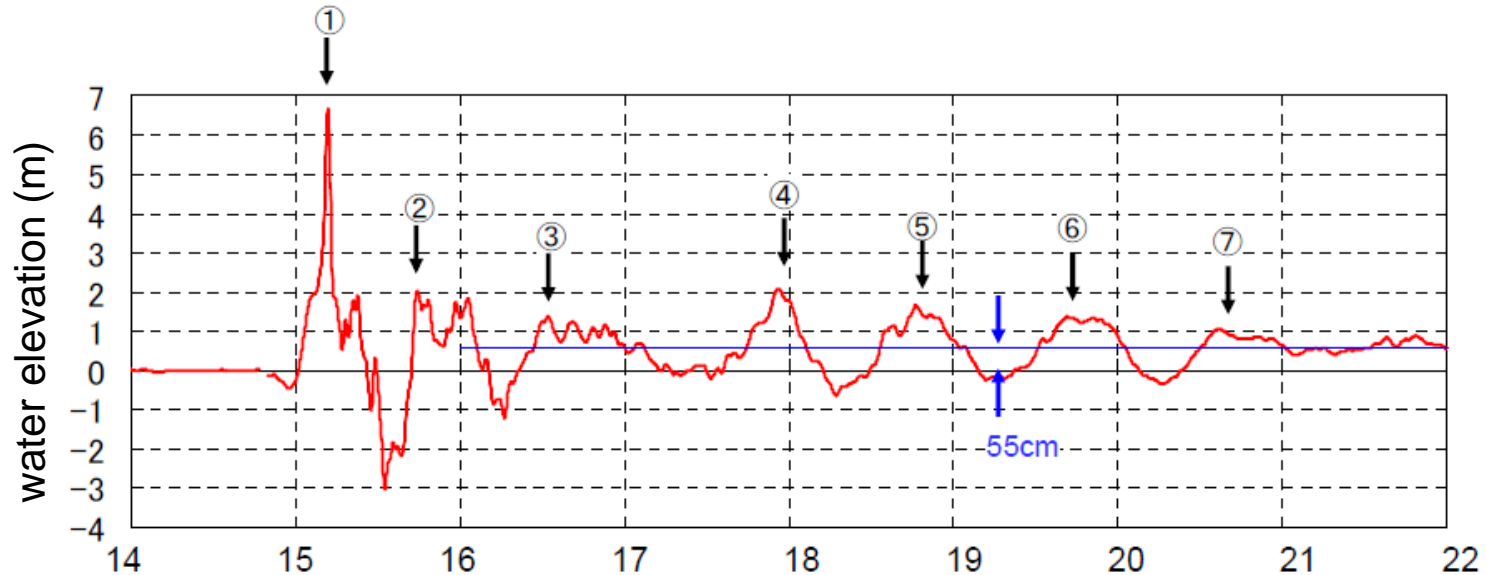
Tsunami shape near the source

JLT on March 11

Measured by GPS wave gauge installed
at the place with the depth 200m off Kamaishi

- The first wave is the maximum with 6.5 m amplitude at 26 minute after the quake
- 6 waves follow with a 1 m amplitude and 50m periods

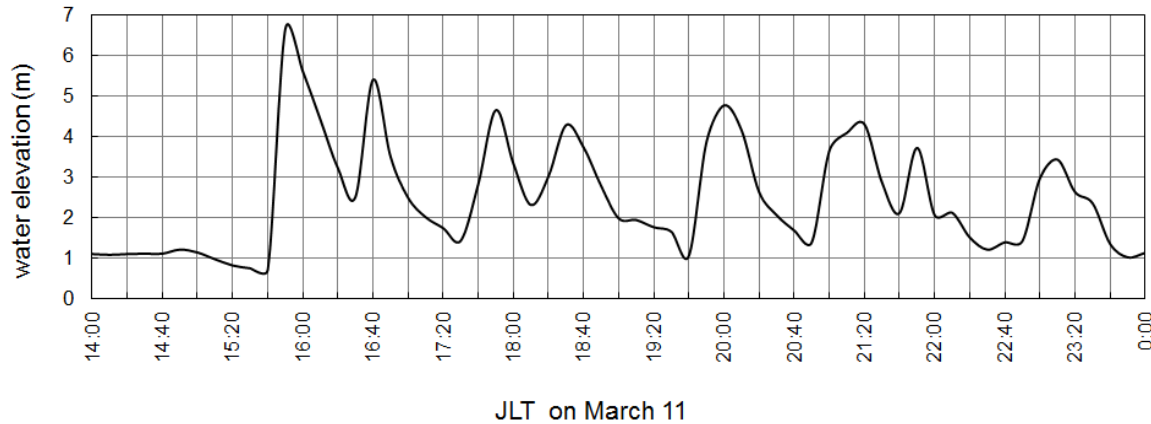
The Naruse River, 0.5 km upstream from the Sendai Bay Coast

The first wave is bore like and has the maximum at 15:50 which estimates the peak time 15:49 at the coast, 63 minutes after the quake.

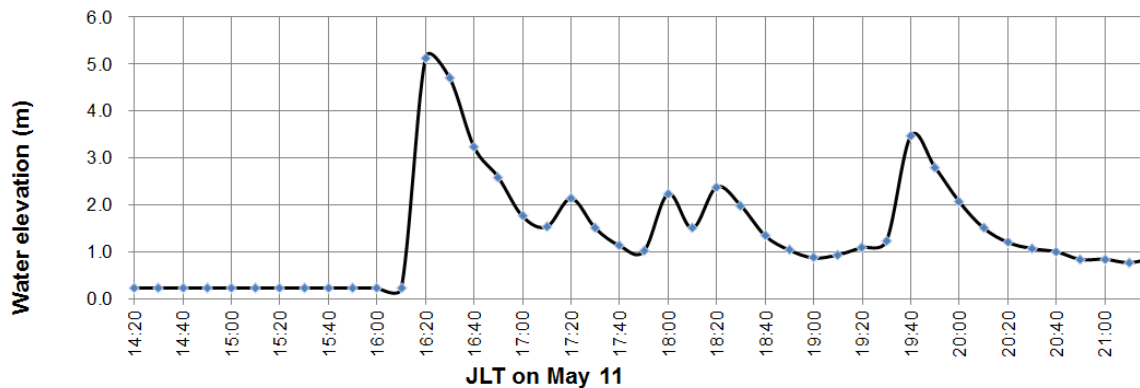
The Abukuma River, 10km upstream from the Sendai Bay Coast

The first wave is bore like and has the maximum at 16:20 which estimates the peak time 15:55 at the coast, 69 minutes after the quake.

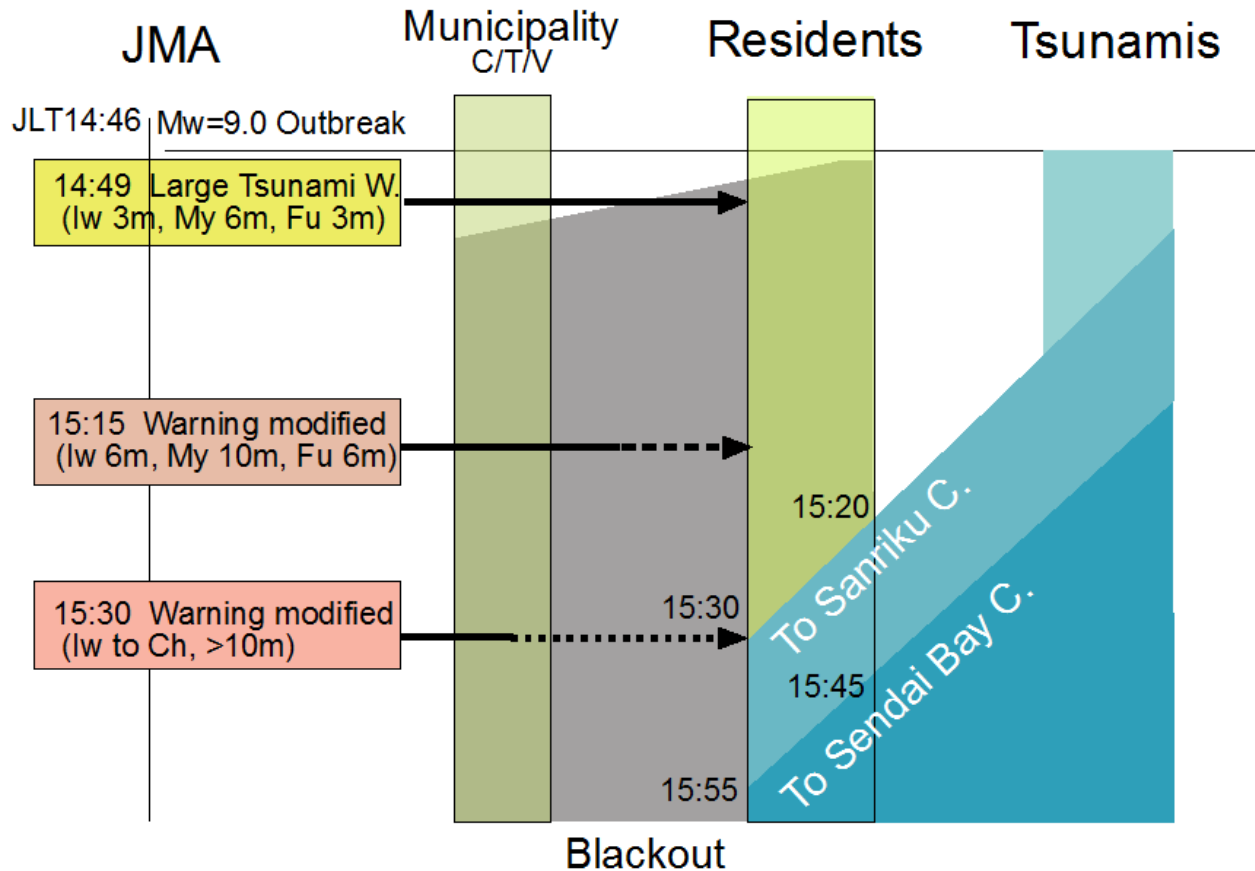
Modified tsunami warning transmission

High underestimate in the Initial tsunami warning gave relief to prevent evacuation. Modified warning did not reach residents in many places by blackout .

- Decrease of the human damage requires
 - disaster mitigation education and evacuation training
 - improvement of the tsunami warning
 - to have mobile radio
 - to avoid the residence in high hazard areas

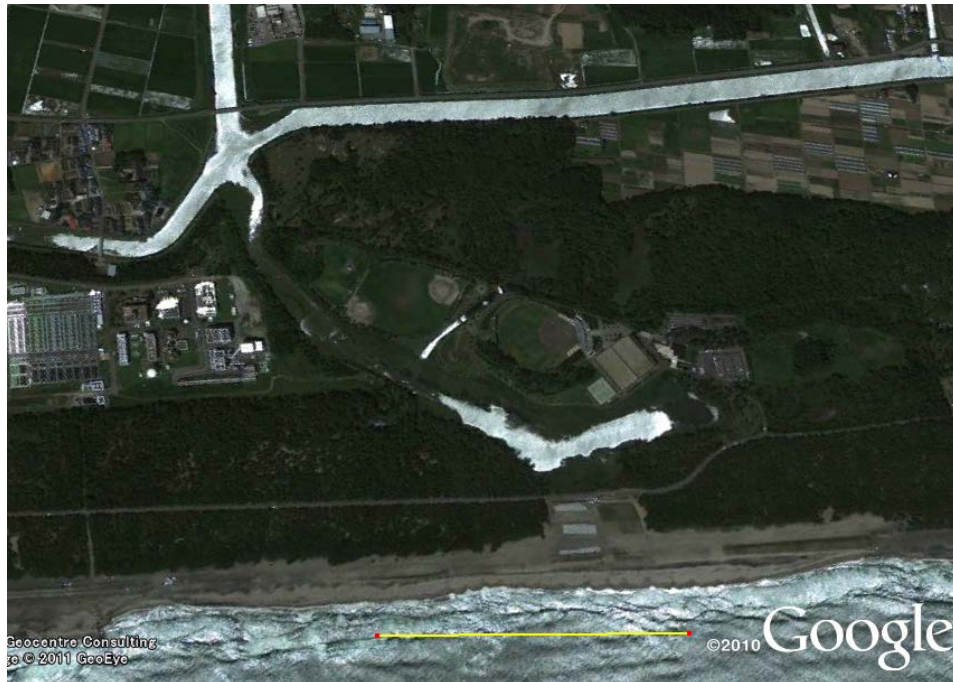
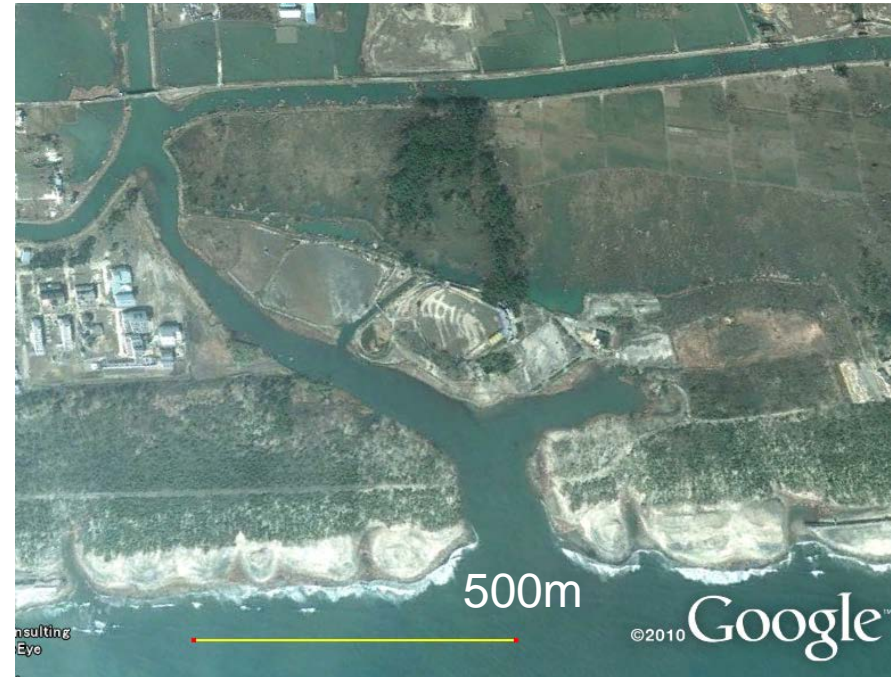
Concentration of the return flow to the channels at Kabasaki, Iwanuma C.

Before, 20090814

After, 20110314

- The return flow was collected to the coastal channel and then to the crossing channel to return back to the sea.
- These channels could be used to control the return flow.

- Reconstruction of robust levees requires
 - restoration of broad beaches
 - control of the return flow concentration through the development of coastal channels and forests
 - anti-erosion armoring at the flow concentration

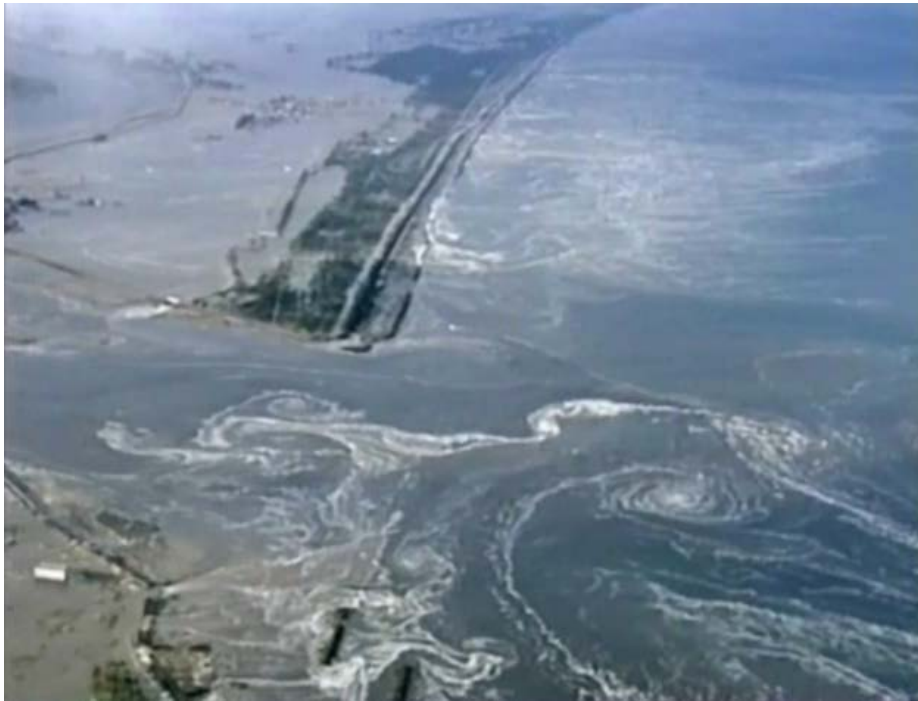
Breach of the coastal levee at the right bank of the Abukuma River mouth

- The Abukuma River mouth at JLT 16:33, March 11
- Turbid water flowing out from the breach and big vortices indicate steadiness and strong erodibility of the return flow.

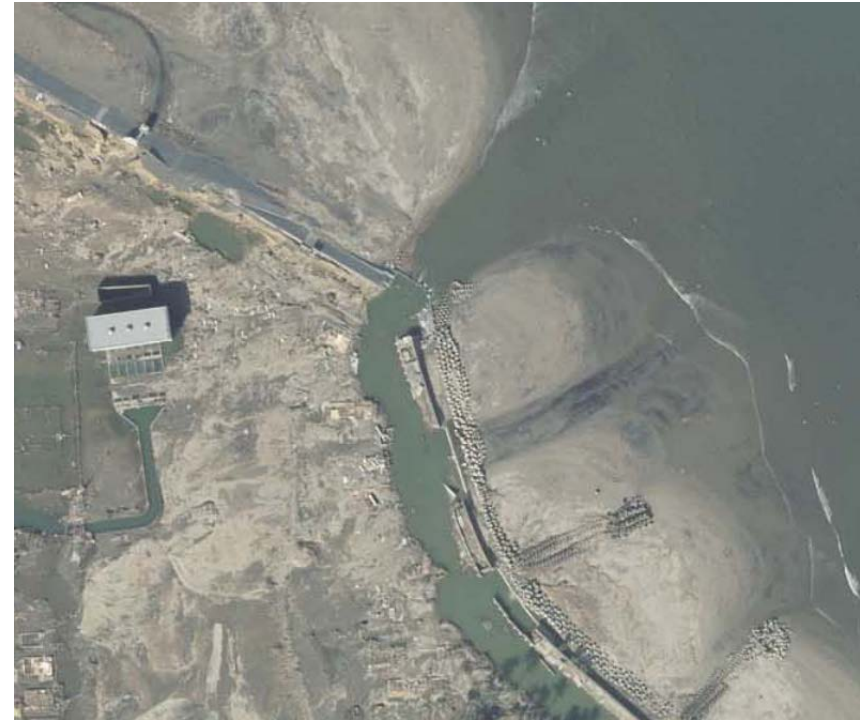
- Aerial photo on March 14 by GSI Japan
- Erosion channel at the back of riverine and coastal levees by the return flow.

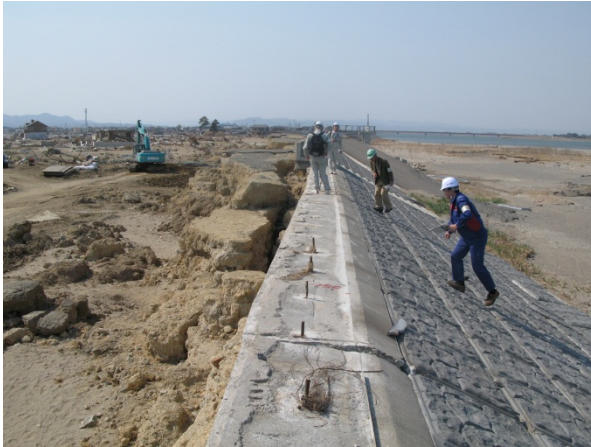
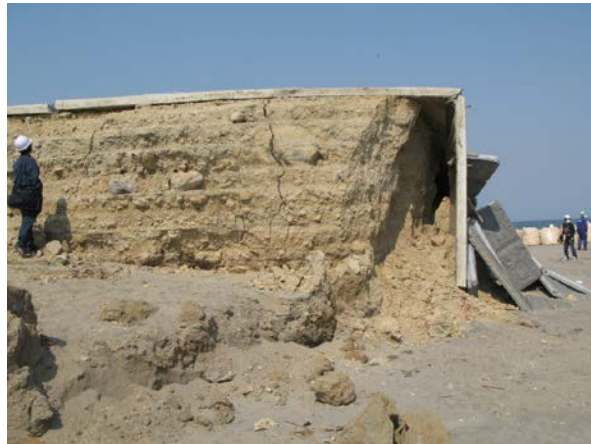
Levee destruction at the right bank of the Abukuma River mouth

➤ Undamaged fore-slope and eroded back-slope of the riverine levee. The vertical concrete blocks at the top called parapet were flushed away.

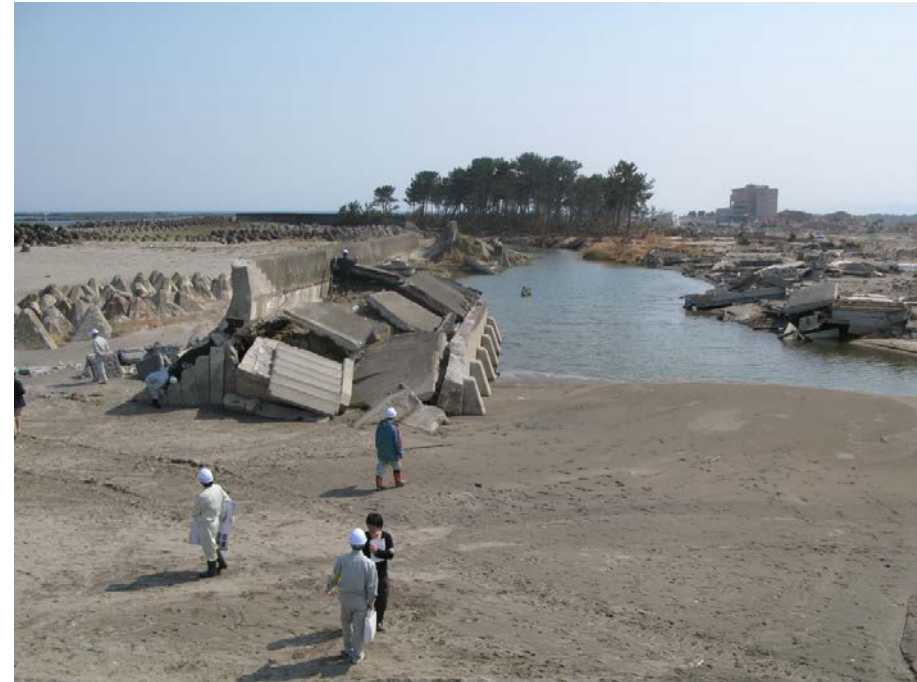
- The backland of the coastal levee was eroded to form a channel.
- The concrete block with wave returning was broken at some place.
- The boundary of the riverine and coastal levees was breached.

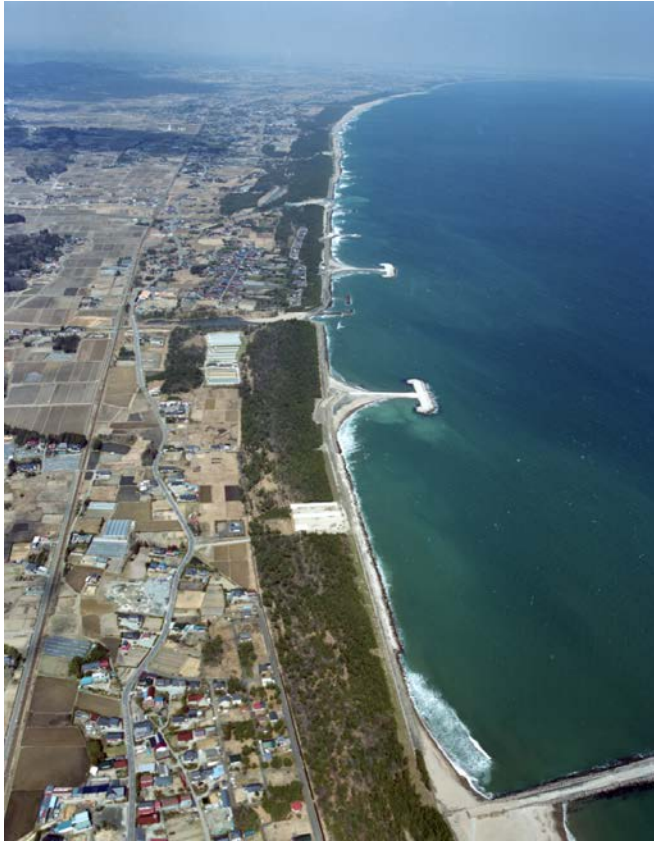
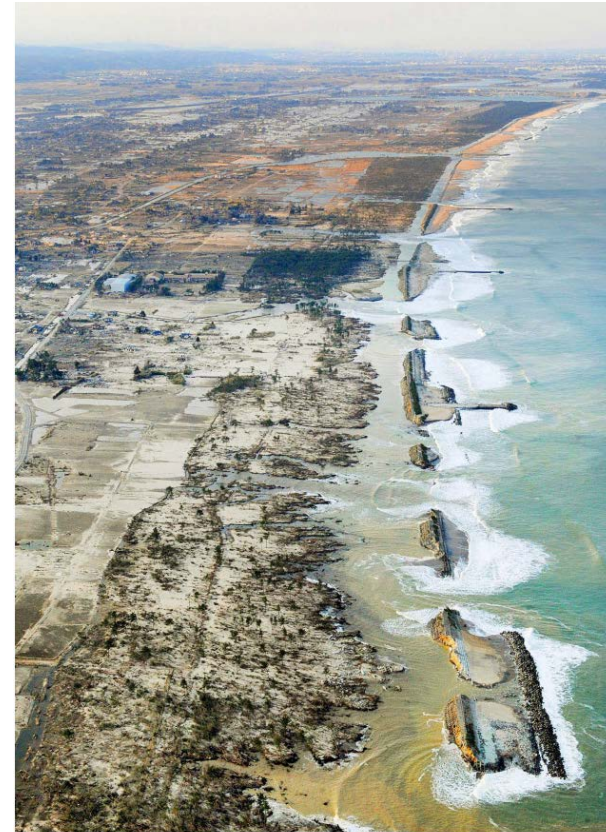
Catastrophic destruction of coastal levees in the Yamamoto Coast, Sendai Bay area

Before the tsunamis

After the tsunamis

T-jetties were constructed to prevent beach erosion.
Thin beaches raise the levee destruction here and there by the flood tsunamis.
The return flow concentrated to the destructed points to erode the land and levees.

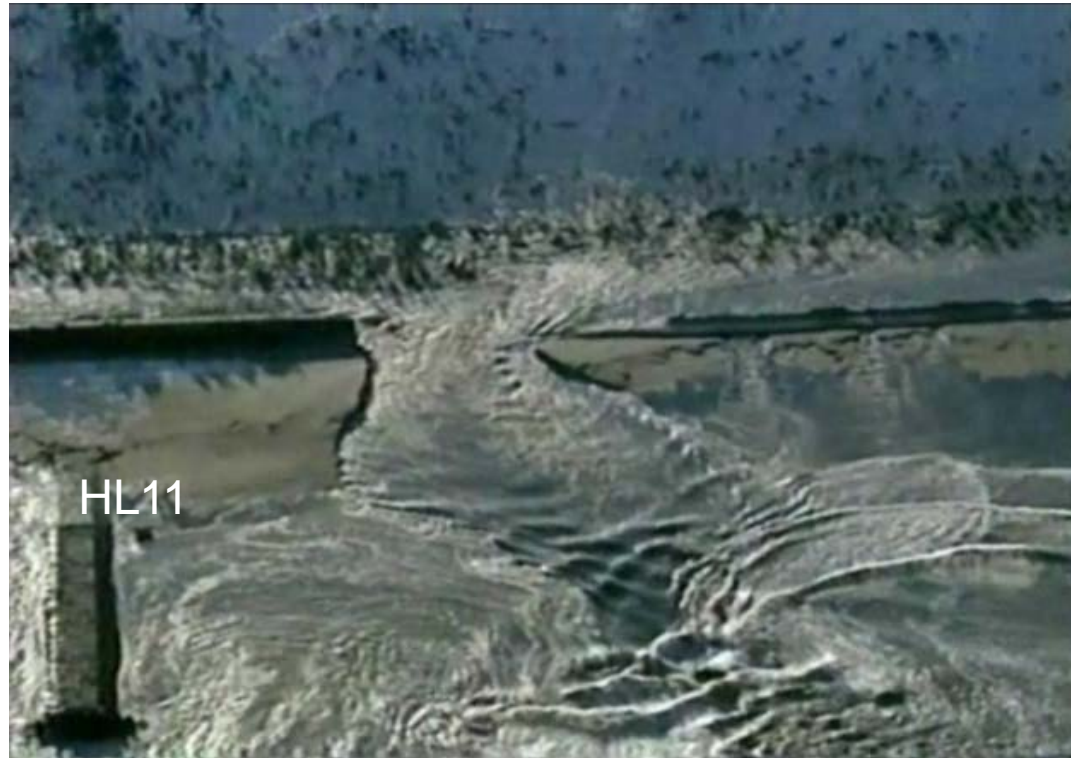
Concentration of return flow to the breach point at Watari T. , videoed by a helicopter at JLT 16:35

- At the moment, huge amount of sea water filled inundation area.
- The return flow along the back of the levee and through the coastal forests concentrated toward the breach point to erode the land and levees.

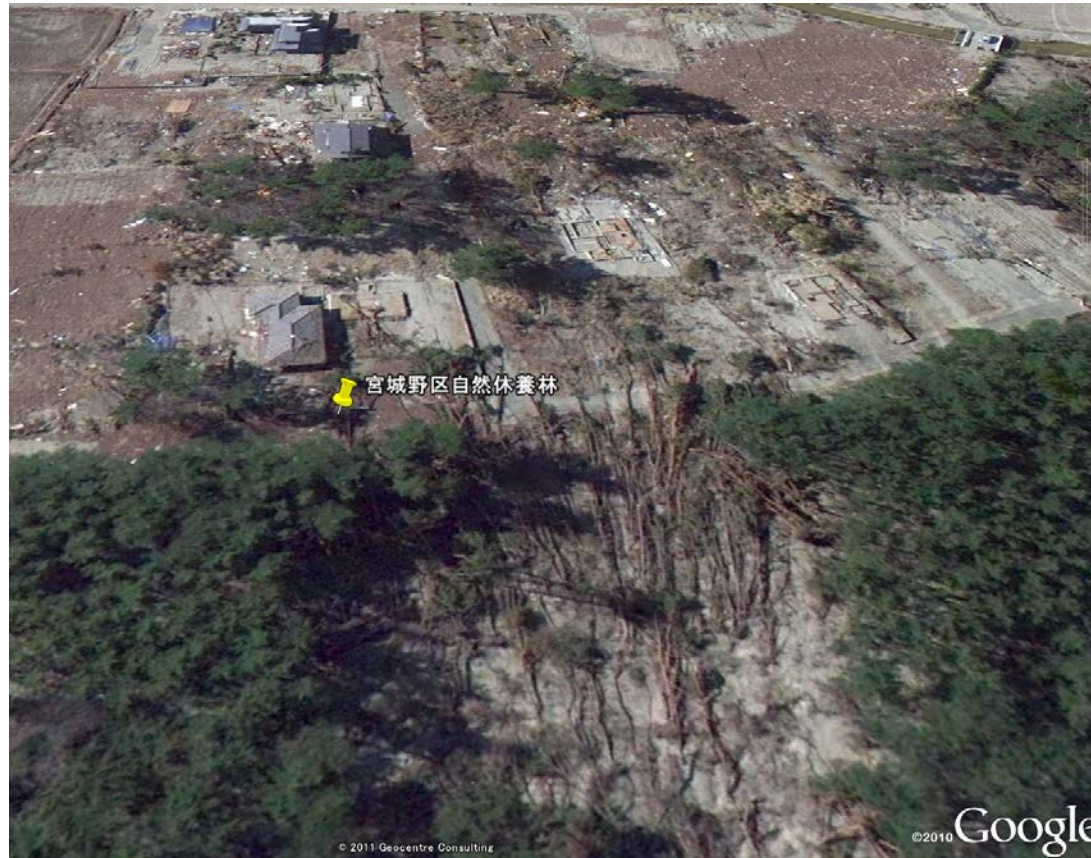
Bird eye view of the fallen woods, Miyagino Bor., Sendai C.

The tsunamis fell coastal forests to washout the houses behind.
The houses behind non-fallen forests were secured.

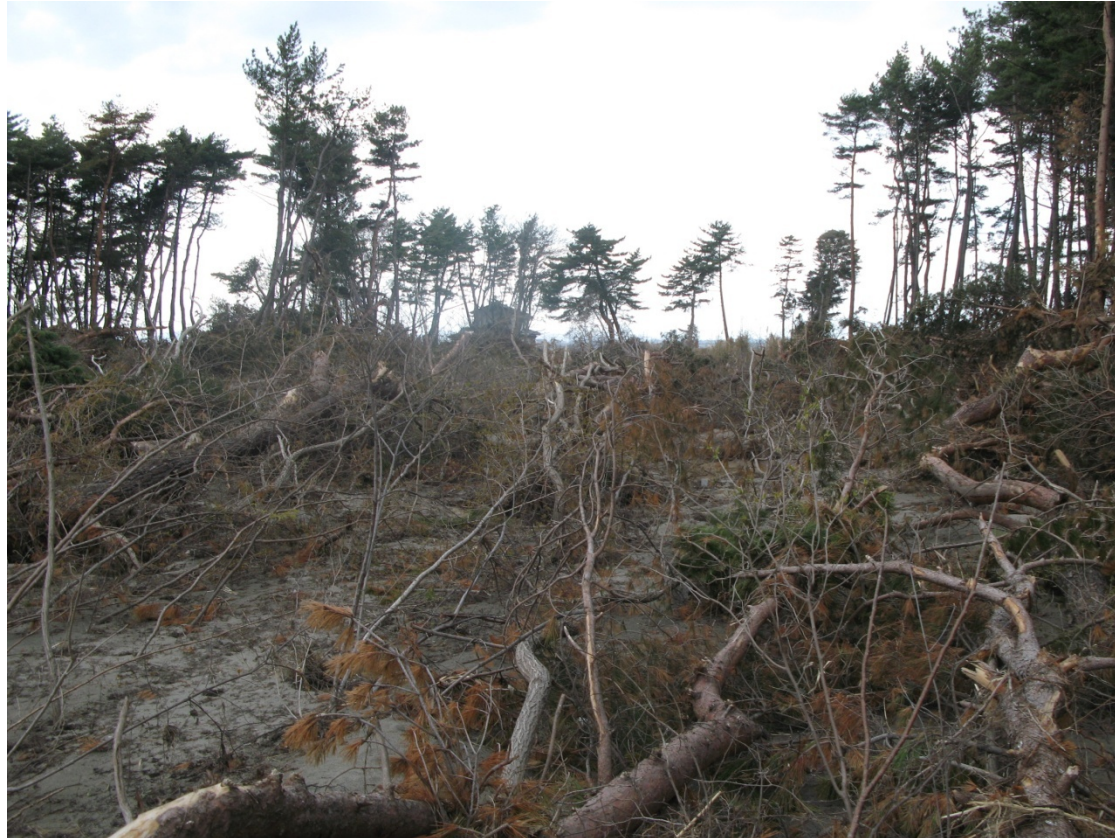
Miyagino Bor., Sendai C.

Fallen woods by domino topping?

There would be feedback effects that fallen trees promote flow concentration which again promotes tree falling. High pine trees could caused domino topping.
